Highway Structures & Bridges
Inspection & Assessment

CS 460

Management of corrugated steel buried structures

This document details the management requirements for corrugated steel buried structures.

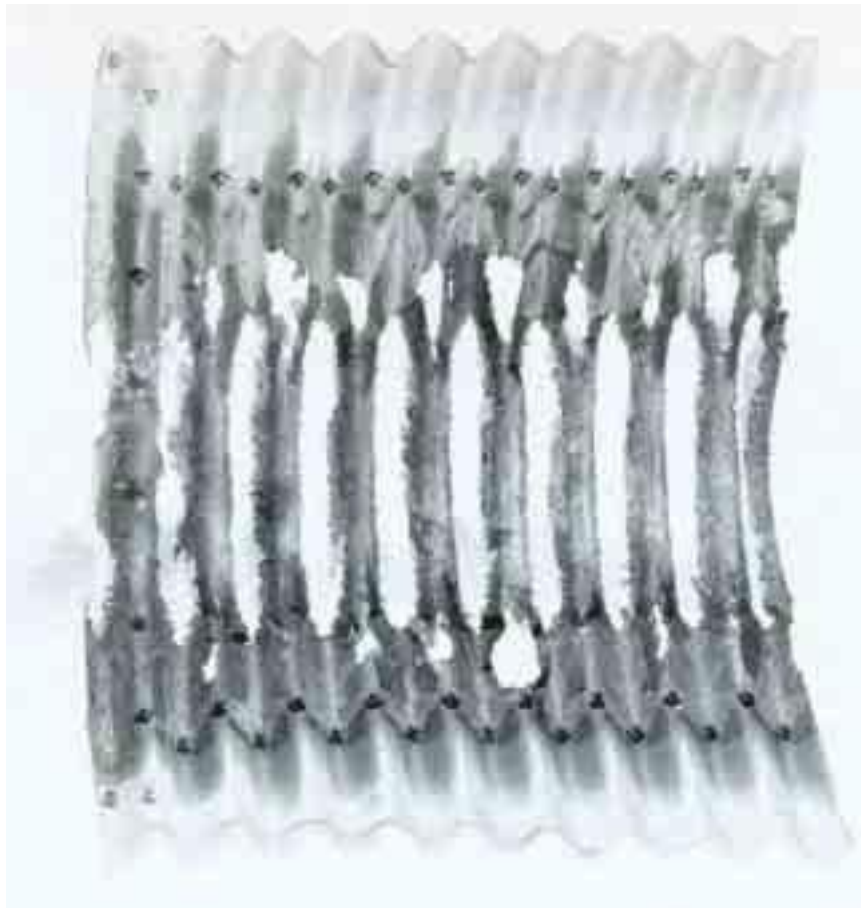
Figure B1 shows the deterioration in the invert of a 1.8 m-diameter CSBS. This structure was subsequently replaced with a larger diameter helically wound corrugated-steel pipe incorporating a reinforced concrete paving. If the deterioration had been less severe it might have been possible to install a reinforced concrete structural paving.

Figure B.1 Example of extreme corrosion in the invert of a structure subject to scour (this 30 year old structure was not provided with a paving or bitumen coating)

Scour can occur in CSBS used as culverts, that do not have a paving and are subject to flows of water where the velocity is sufficient to carry sand, gravel and stones through them, potentially causing extensive deterioration of the invert of a CSBS. The scouring due to waterborne debris can also remove or damage the protective coatings to the steel, exposing it to rapid corrosion.

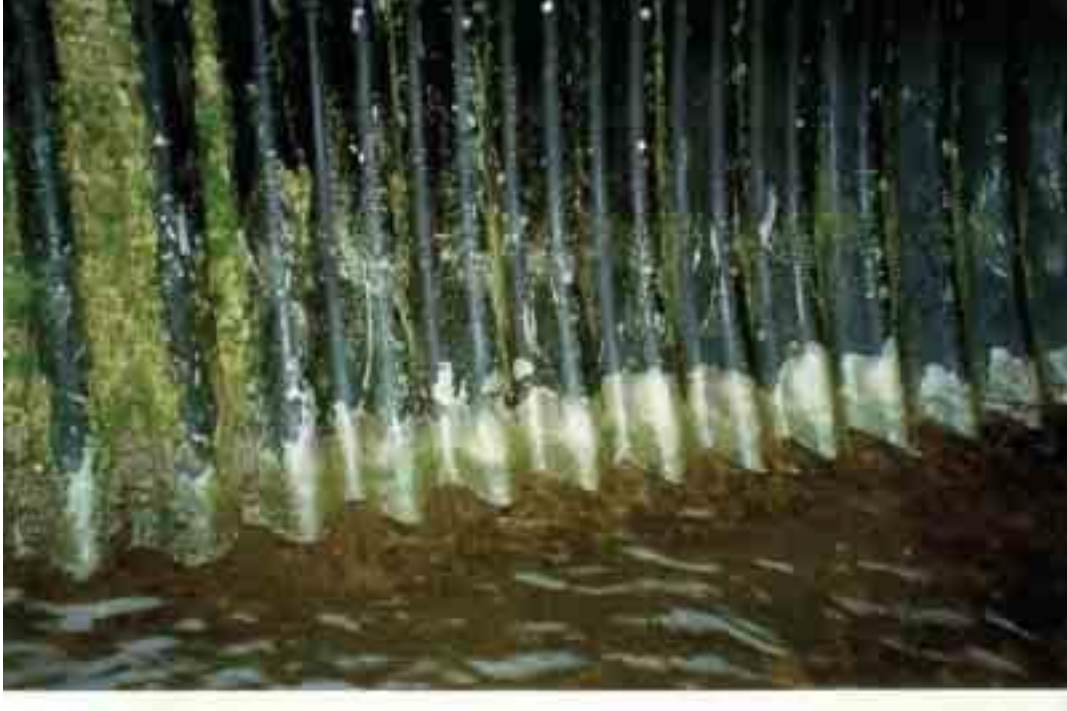
Figure B.2 Deterioration of bitumen coating along the wet/dry line in low flow condition

Figure B2 shows typical deterioration of a bitumen coating caused by frequent cycles of wetting and drying. Figure B3 shows the deterioration of the bitumen coatings above the paving in a pipe arch structure due to overtopping through turbulent flow. In Figure B3 the bitumen coating was in good condition elsewhere in the structure.

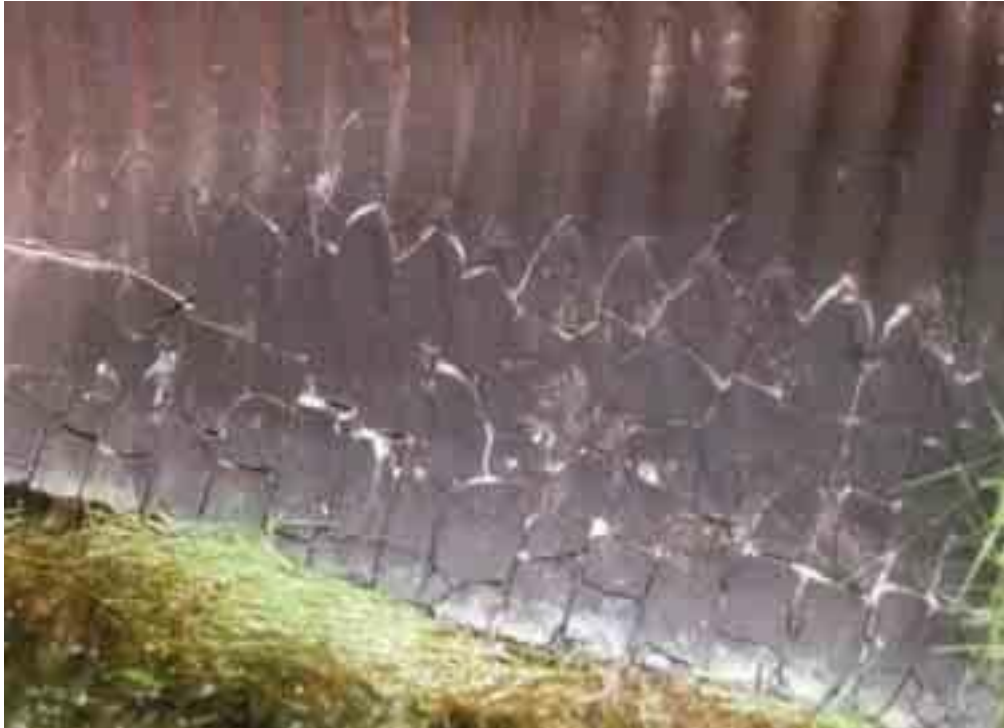
Figure B.5 Cracking in a bitumen paving due to exposure to sunlight

Bitumen pavings are generally hard wearing and resistant to scour by waterborne debris. The most common form of deterioration of bitumen pavings takes the form of cracking as the bitumen hardens with age and loses its more volatile constituents. This is usually most evident at the ends of the structure (particularly those with bevelled ends) exposed to direct sunlight and potentially turbulent water flows. Figure B5 shows an example of the form of deterioration.

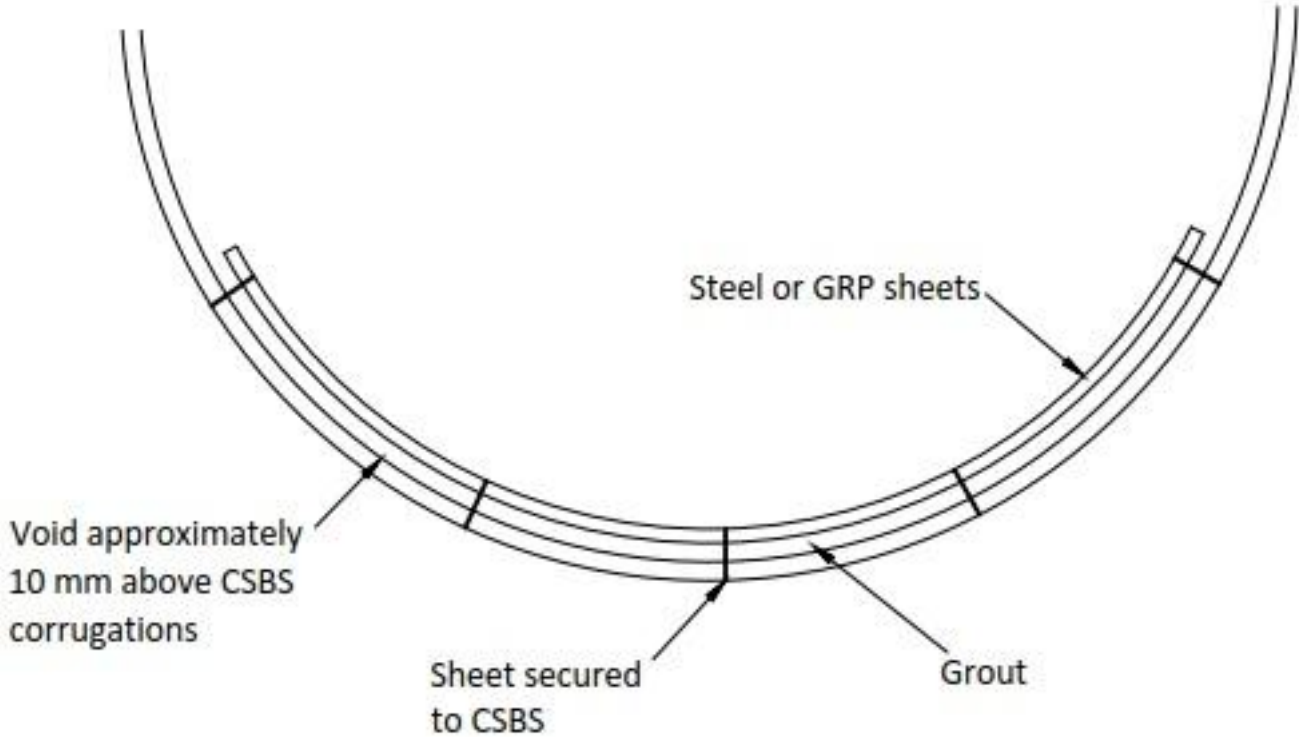
Coatings that are reapplied to the wet/dry zone are likely to be quickly removed and again expose the underlying zinc coating and steel to the environment. The placement of a paving to contain the flow would protect the wet/dry zone, but there are a number of cheaper options. For example, the use of pre-coated galvanised steel or glass-reinforced plastic (GRP) sheets as shown in Figure B7. This can be done in the following manner:

Figure B.7 Use of liner plates to protect an invert

- 1) Remove any loose secondary coatings and clean exposed surface.;
- 2) Coat the galvanised surface or exposed steel with a cold-applied bitumen-based paint or suitable secondary coating;
- 3) Secure the pre-coated galvanised steel or GRP sheets to the culvert walls to cover at least the wet/dry zone up to the height of the mean winter water level plus 200 mm; and,
- 4) Fill the void between the wall of the CSBS and the sheet with, for example, a cementitious grout or water-reactive polyurethane.

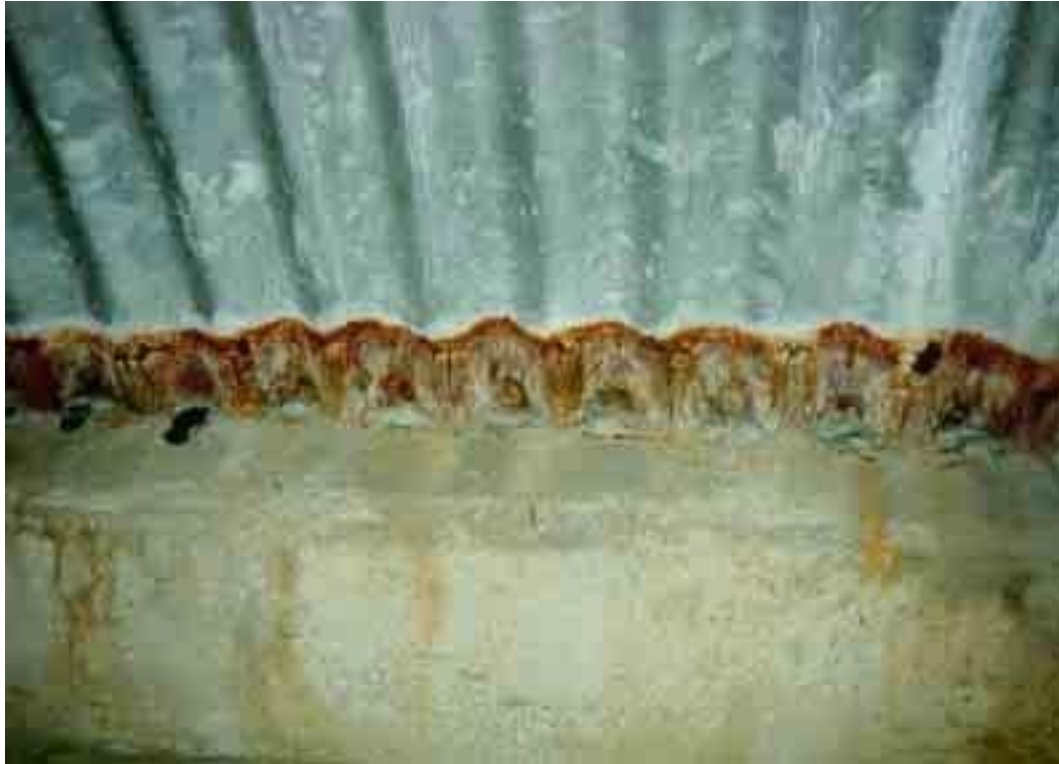
Figure B9 shows the deterioration in a 25-year-old plain galvanised arch structure. Water laden with deicing salts has percolated into the structure below the edges of the carriageway. Corrosion is most noticeable around bolt holes and plate edges in the crown and also where it has ponded in the seating channel of the arch. The rest of the structure is in good condition.

Figure B.9 Deterioration at the arch seating of a plain galvanised arch structure due to seepage and ponding of water containing de-icing salts

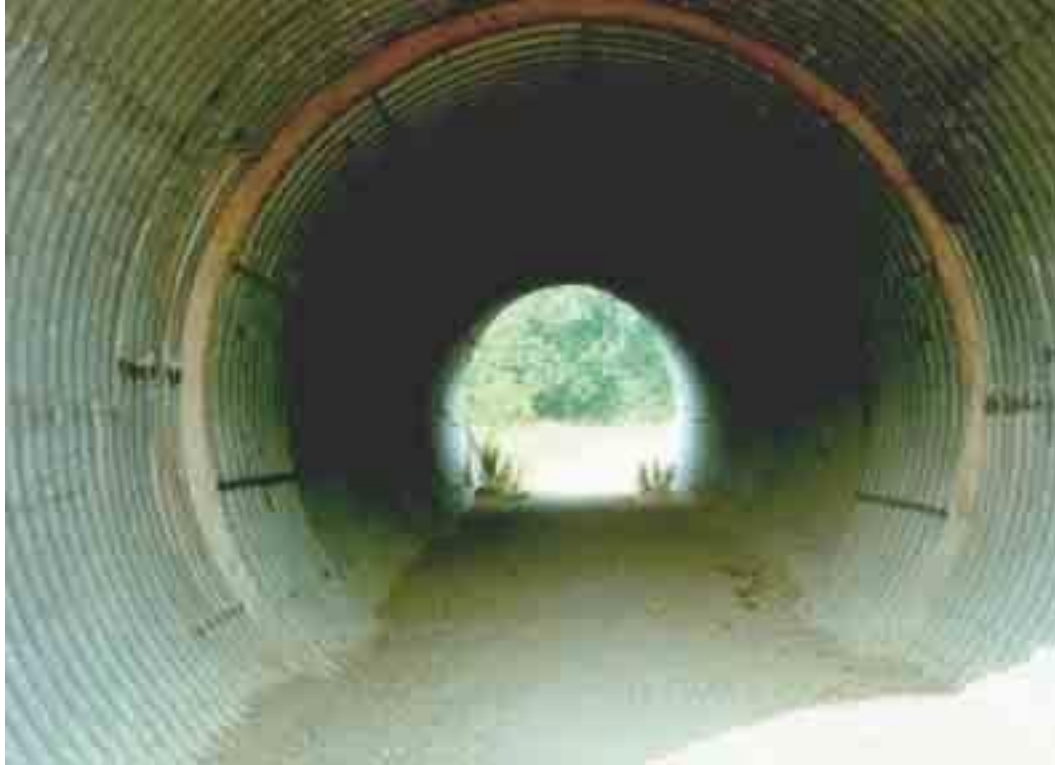
Figure B.10 Use of liner plates to repair a bolted segmental CSBS showing deterioration below the edge of the carriageway due to seepage of water containing deicing salts

- 1) Grout the backfill close to points of seepage with a water-reactive polyurethane grout or similar to eliminate or reduce seepage.;
- 2) Remove corrosion by sand or shot blasting to achieve a clean steel finish.;
- 3) If the appearance of the structure is important, i.e. an underpass, then a visually attractive finish could be applied to the structure by applying an appropriate primer and coating system; for example, a zinc phosphate primer followed by a high-build primer and an acrylic finishing coat.;
- 4) If the appearance of the structure is unimportant, then the finish to the structure could be formed from a moisture-tolerant primer followed by a suitable coating such as cold-applied bitumen.
- 5) If the deterioration is severe but localised then liner plates can be used to strengthen the structure. Figure B10 shows the use of liner plates in an underpass.

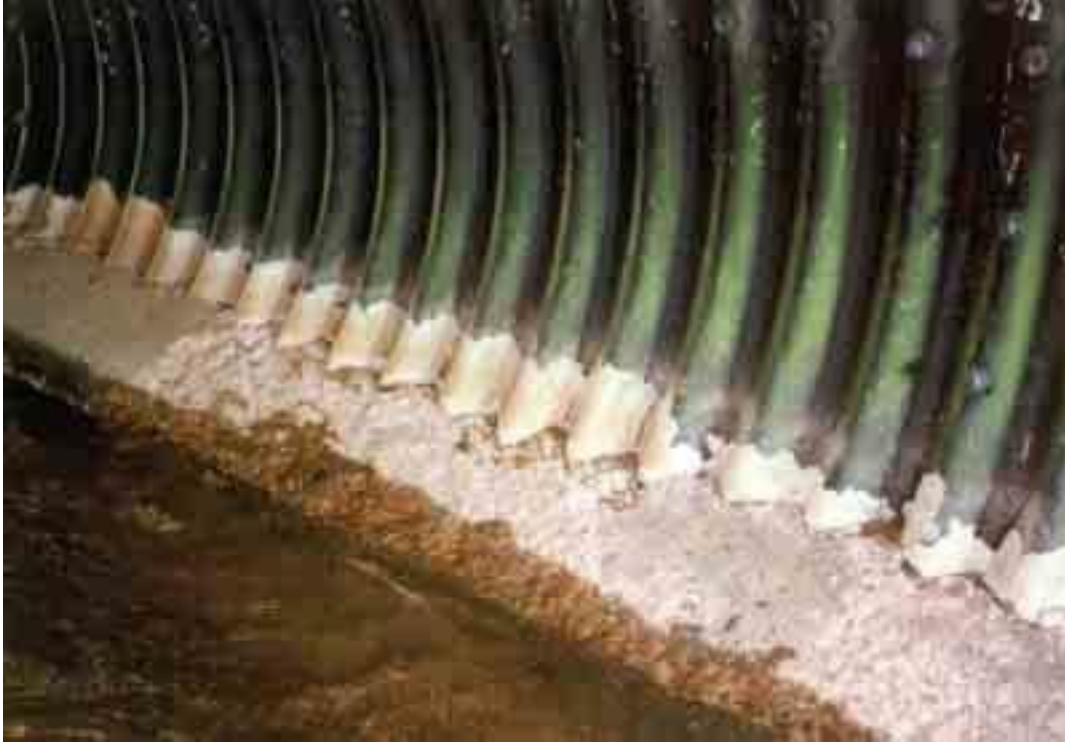
Figure B.11 Damaged bitumen coating caused by overtopping of paving during turbulent flow

A possible solution to increase the stability is the provision of a structural paving. Details of various arrangement for structural pavings are shown in Figures B11 to B14, and as indicated in Alexander et al 1994 [Ref 14.I] and in 'Invert replacement of corrugated metal structural plate pipe' Ikerd 1984 [Ref 11.I].
