Design Manual for Roads and Bridges

CS 460

Management of corrugated steel buried structures

This document details the management requirements for corrugated steel buried structures.

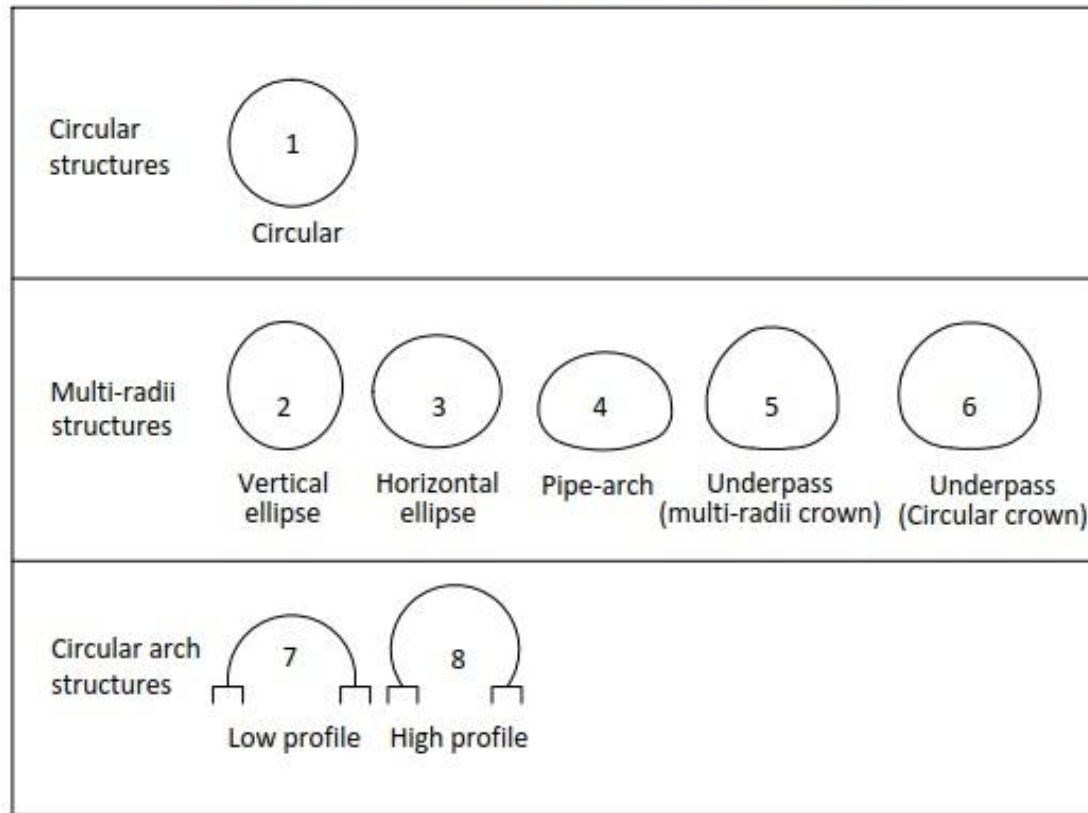
Figure A.1 Typical profiles of CSBS commonly installed in the UK

Profiles of short-span structures (spans less than 8 metres)

Profiles of larger structures incorporating thrust beams

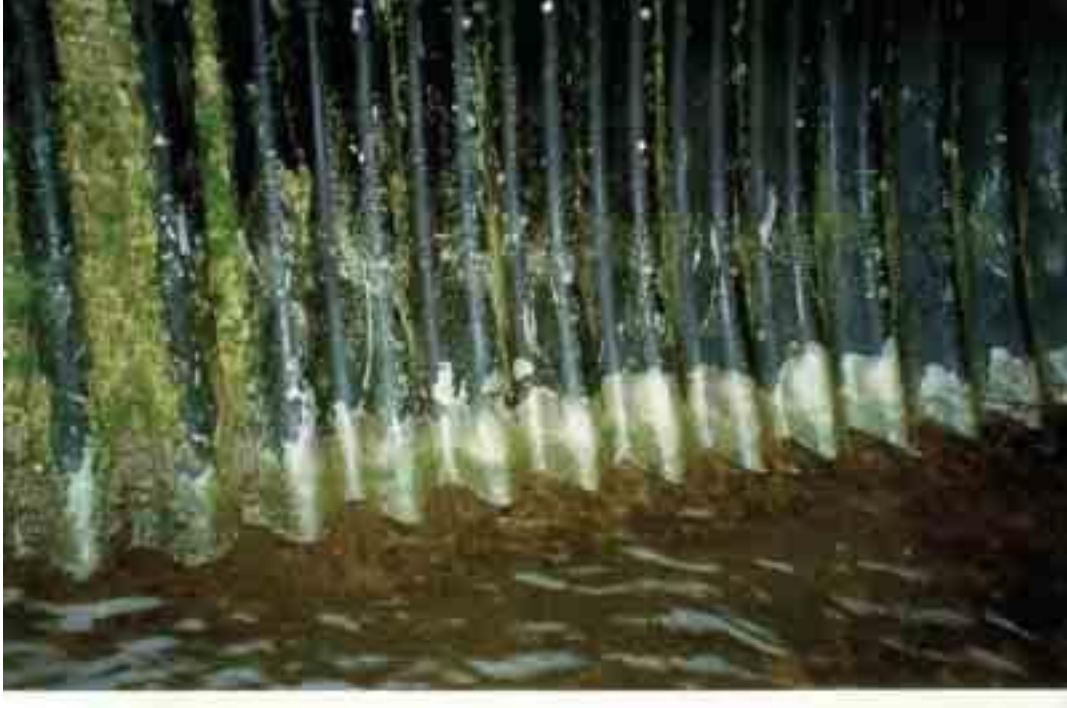
Figure B.2 Deterioration of bitumen coating along the wet/dry line in low flow condition

Figure B2 shows typical deterioration of a bitumen coating caused by frequent cycles of wetting and drying. Figure B3 shows the deterioration of the bitumen coatings above the paving in a pipe arch structure due to overtopping through turbulent flow. In Figure B3 the bitumen coating was in good condition elsewhere in the structure.

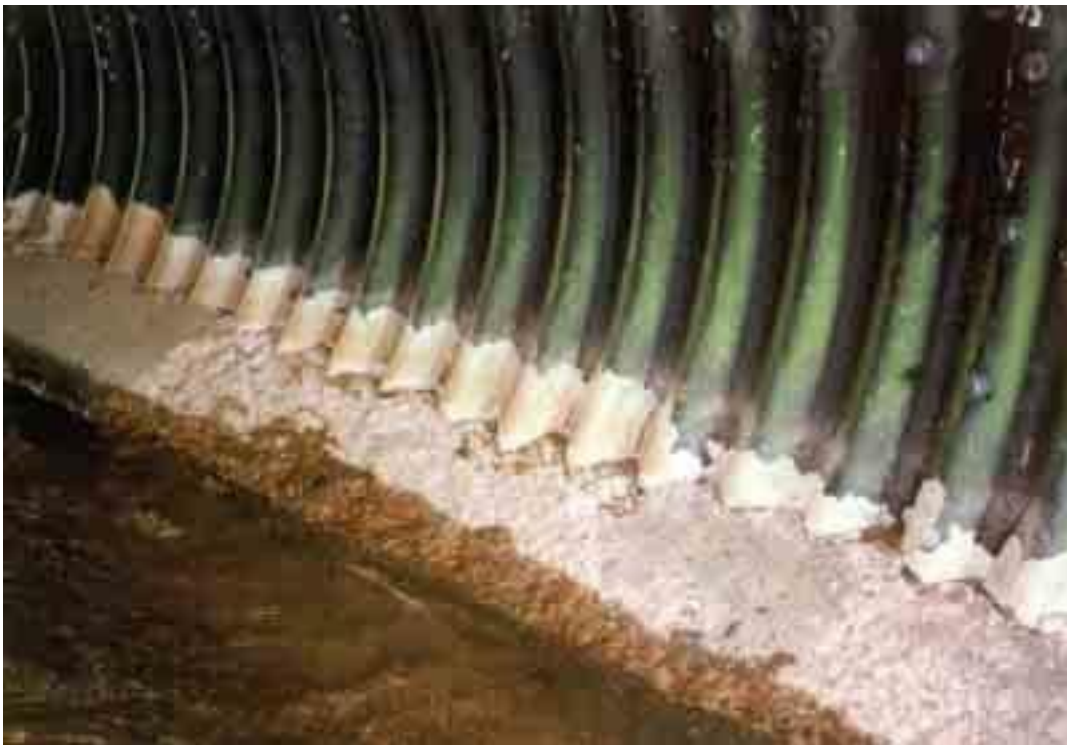
Figure B.3 Damaged bitumen coating caused by overtopping of paving during turbulent flow

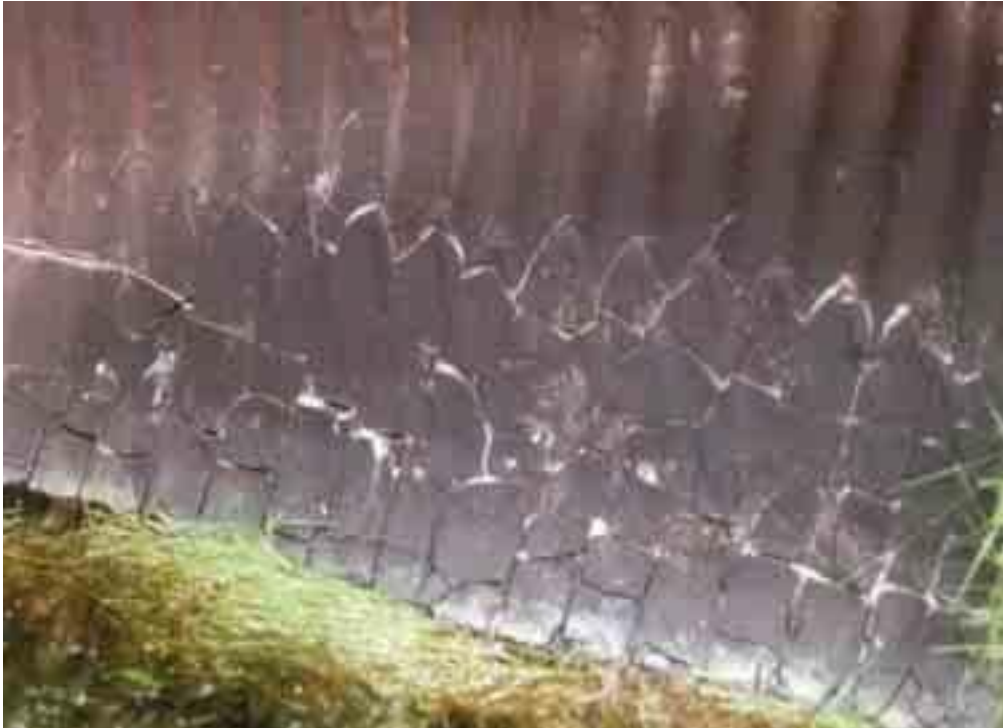
Figure B.5 Cracking in a bitumen paving due to exposure to sunlight

Bitumen pavings are generally hard wearing and resistant to scour by waterborne debris. The most common form of deterioration of bitumen pavings takes the form of cracking as the bitumen hardens with age and loses its more volatile constituents. This is usually most evident at the ends of the structure (particularly those with bevelled ends) exposed to direct sunlight and potentially turbulent water flows. Figure B5 shows an example of the form of deterioration.

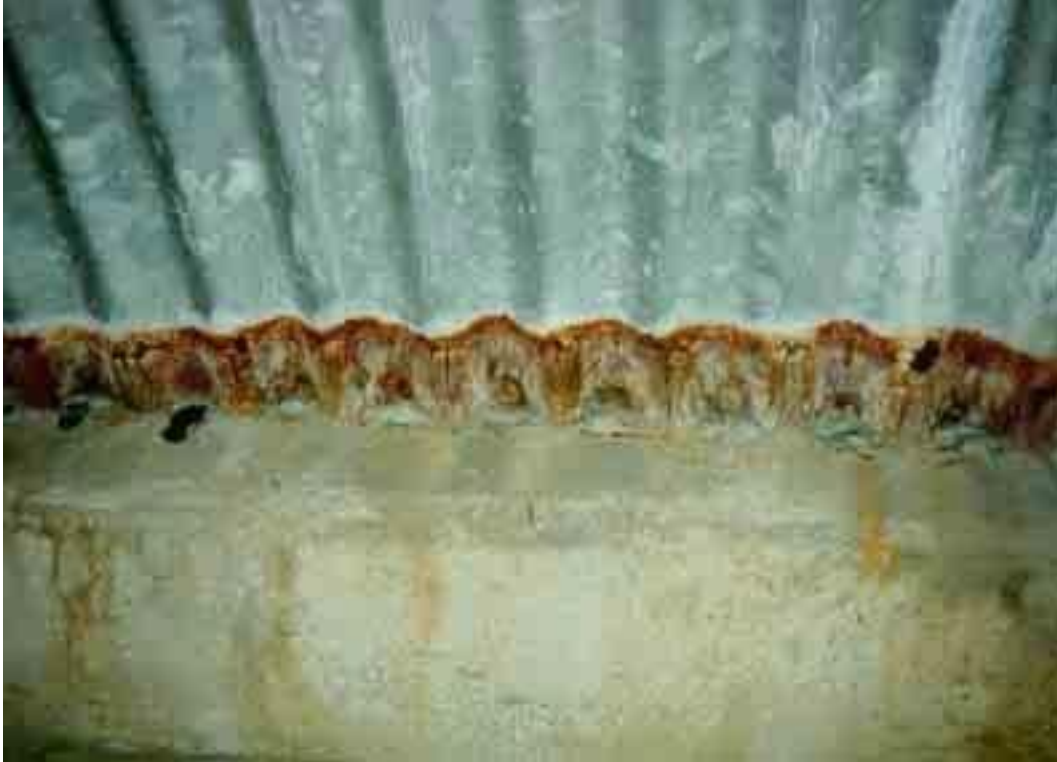
Figure B.9 Deterioration at the arch seating of a plain galvanised arch structure due to seepage and ponding of water containing de-icing salts

Figure B9 shows the deterioration in a 25-year-old plain galvanised arch structure. Water laden with deicing salts has percolated into the structure below the edges of the carriageway. Corrosion is most noticeable around bolt holes and plate edges in the crown and also where it has ponded in the seating channel of the arch. The rest of the structure is in good condition.

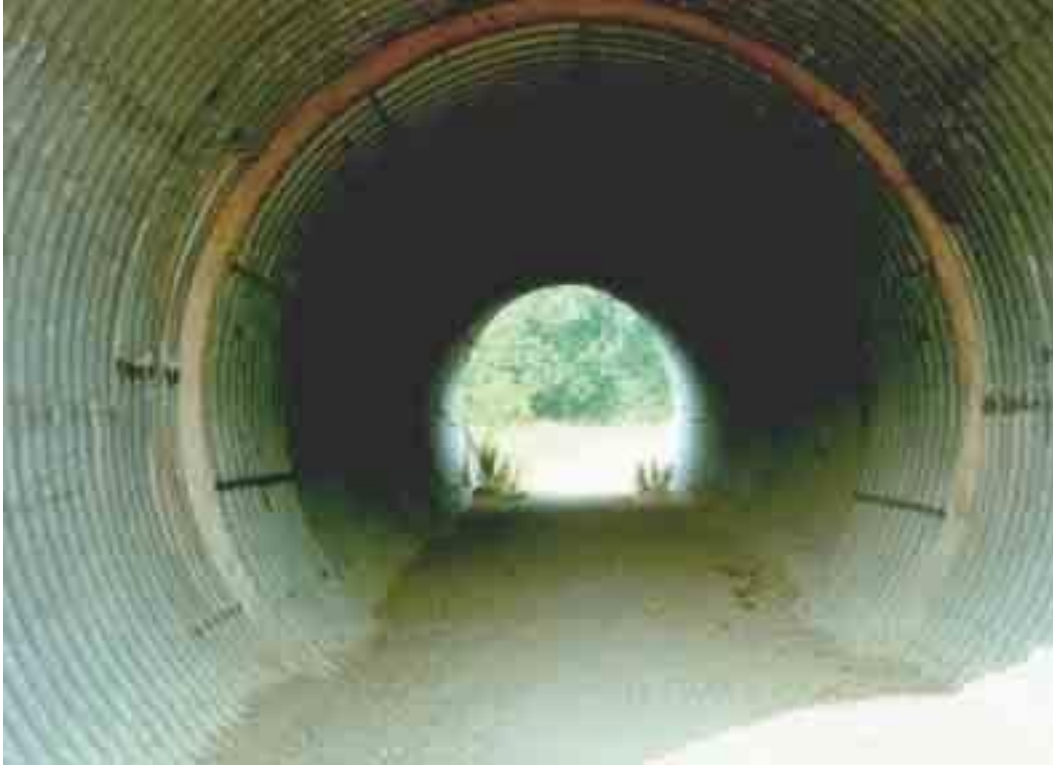
Figure B.10 Use of liner plates to repair a bolted segmental CSBS showing deterioration below the edge of the carriageway due to seepage of water containing deicing salts

- 1) Grout the backfill close to points of seepage with a water-reactive polyurethane grout or similar to eliminate or reduce seepage.;
- 2) Remove corrosion by sand or shot blasting to achieve a clean steel finish.;
- 3) If the appearance of the structure is important, i.e. an underpass, then a visually attractive finish could be applied to the structure by applying an appropriate primer and coating system; for example, a zinc phosphate primer followed by a high-build primer and an acrylic finishing coat.;
- 4) If the appearance of the structure is unimportant, then the finish to the structure could be formed from a moisture-tolerant primer followed by a suitable coating such as cold-applied bitumen.
- 5) If the deterioration is severe but localised then liner plates can be used to strengthen the structure. Figure B10 shows the use of liner plates in an underpass.

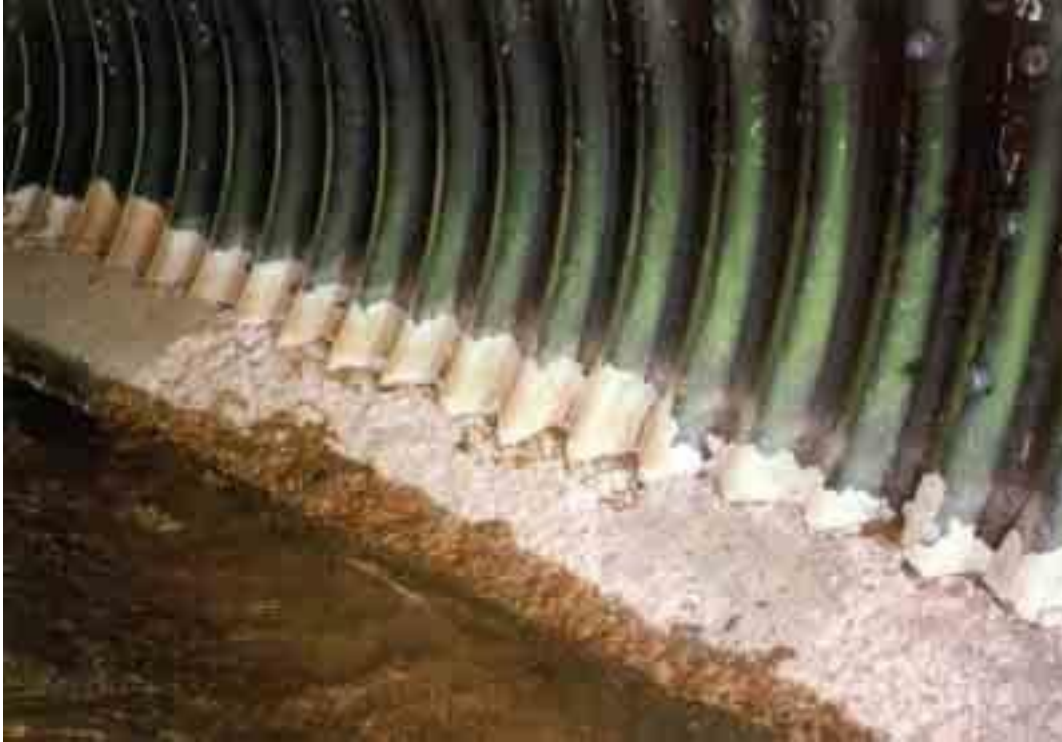
Figure B.11 Damaged bitumen coating caused by overtopping of paving during turbulent flow

A possible solution to increase the stability is the provision of a structural paving. Details of various arrangement for structural pavings are shown in Figures B11 to B14, and as indicated in Alexander et al 1994 [Ref 14.] and in 'Invert replacement of corrugated metal structural plate pipe' Ikerd 1984 [Ref 11.].
