HA 48/93

Maintenance of Highway Earthworks and Drainage

Summary: This Advice Note gives guidance to highway engineers responsible for maintaining earthworks slopes and drainage on trunk roads including motorways.

VOLUME 4	GEOTECHNICS AND DRAINAGE
SECTION 1	EARTHWORKS

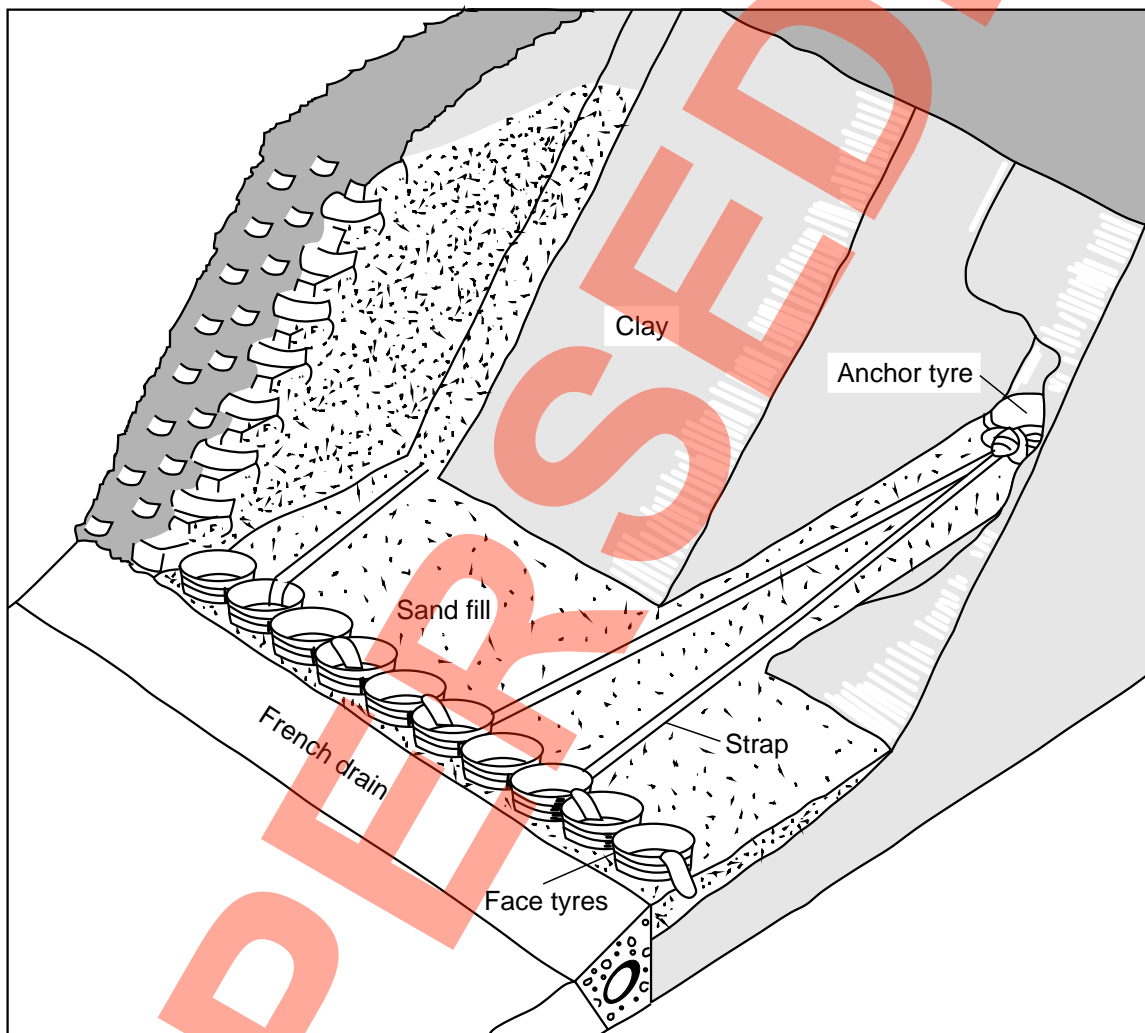
Fig 8/5. SECTIONED VIEW OF ANCHORED TYRE WALL SHOWING LACING LAYOUT

8.22 Anchored tyre walls have only recently been used in the UK. The few that have been constructed include an experimental anchored tyre wall on the A45 in Cambridgeshire (18) and a larger wall at a motorway junction on the M62 near Bradford (29). Reinstatement using an anchored tyre wall (Figure 8/5) involves constructing a wall at the toe of a slope using old car tyres. The side walls of the car tyres are cut away and then they are tied together in layers, and connected at intervals to anchor tyres buried in the embankment or cutting. A filter drain should be constructed at the toe of the slope to collect water from a drainage layer beneath the wall, thus reducing the possibility of water build-up behind the wall.

8.23 The bottom row of tyres is laced together with corrosion resistant flexible straps which are also looped over the anchor tyres at the back of the trenches and tightened. The second layer is then placed with each tyre being staggered longitudinally by half a diameter. Fine granular material is placed in and behind the tyres and in the trenches and levelled and compacted. This procedure is repeated with alternating layers being laced together and tied to anchors: the number of anchors required will depend on the resistance required to ensure stability of the wall. Loose topsoil is allowed to trickle down the front face of the wall to encourage the growth of vegetation. The area above the wall is then backfilled with general fill and formed to a less steep slope angle. The ends of the wall are contoured into the existing slope and the whole repair above the wall is topsoiled.
