Highway Structures & Bridges
Inspection & Assessment

CS 460

Management of corrugated steel buried structures

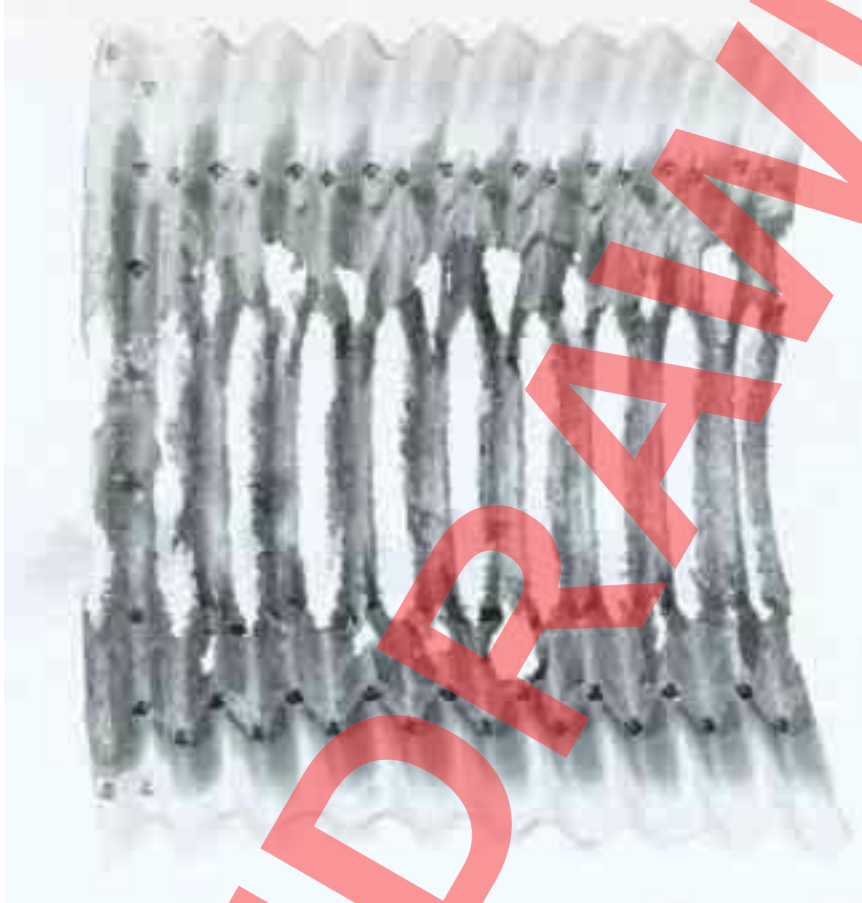
**Figure B.1 Example of extreme corrosion in the invert of a structure subject to scour
(this 30 year old structure was not provided with a paving or bitumen coating)**

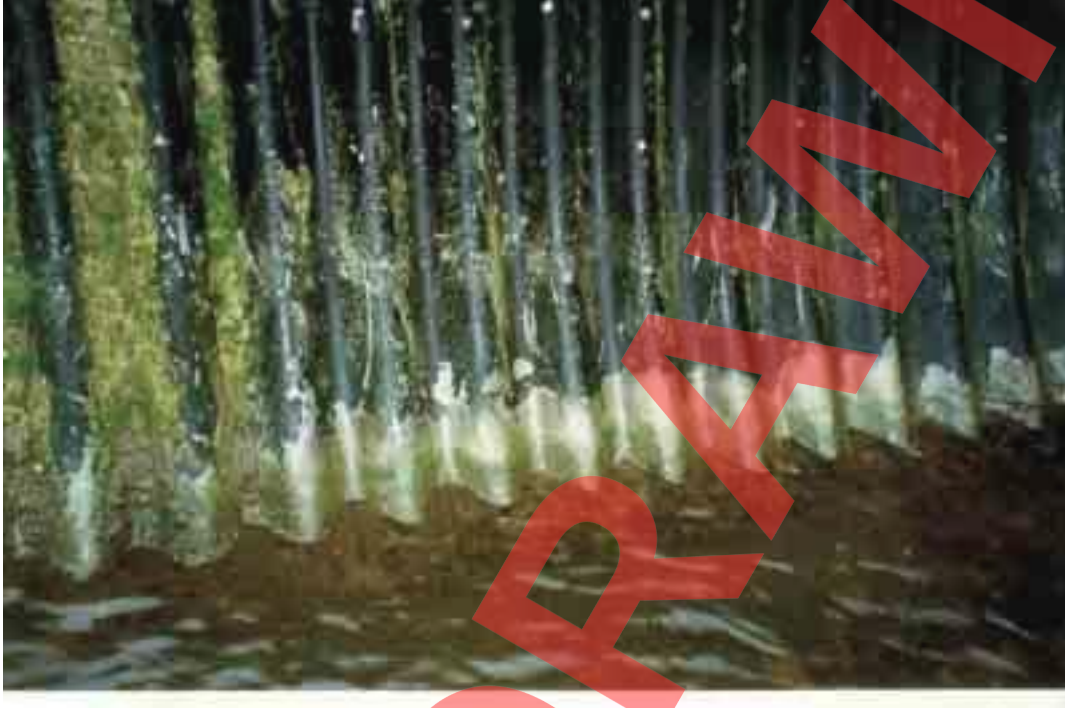
Figure B.2 Deterioration of bitumen coating along the wet/dry line in low flow condition

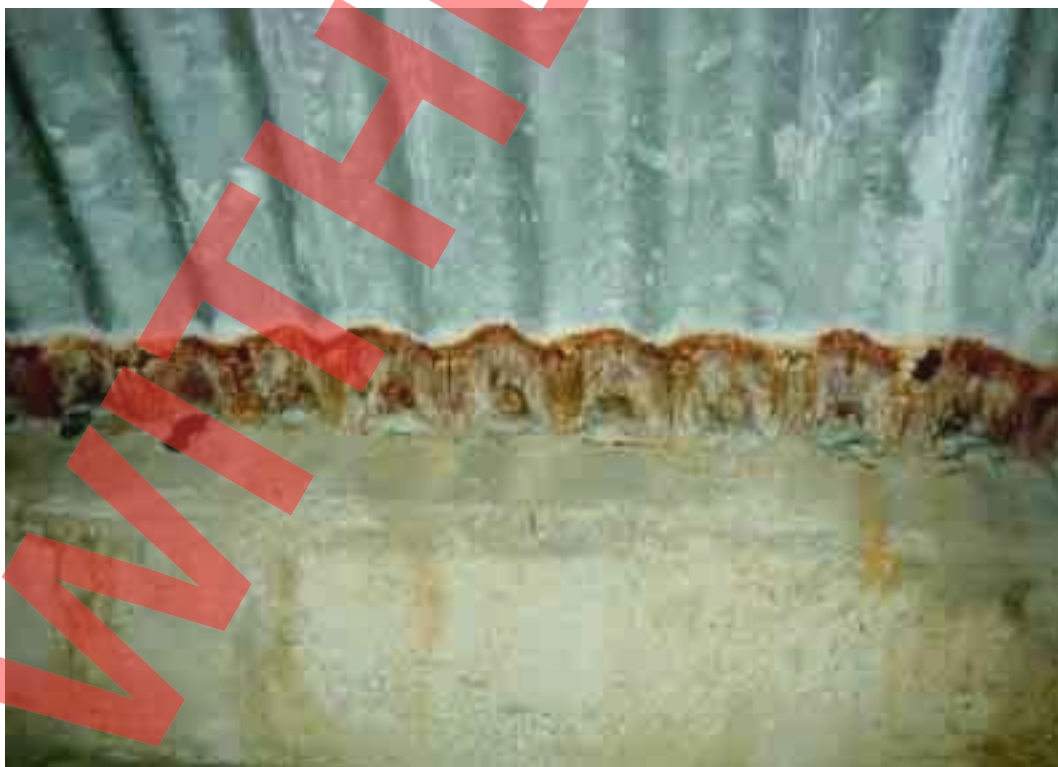
Figure B.9 Deterioration at the arch seating of a plain galvanised arch structure due to seepage and ponding of water containing de-icing salts

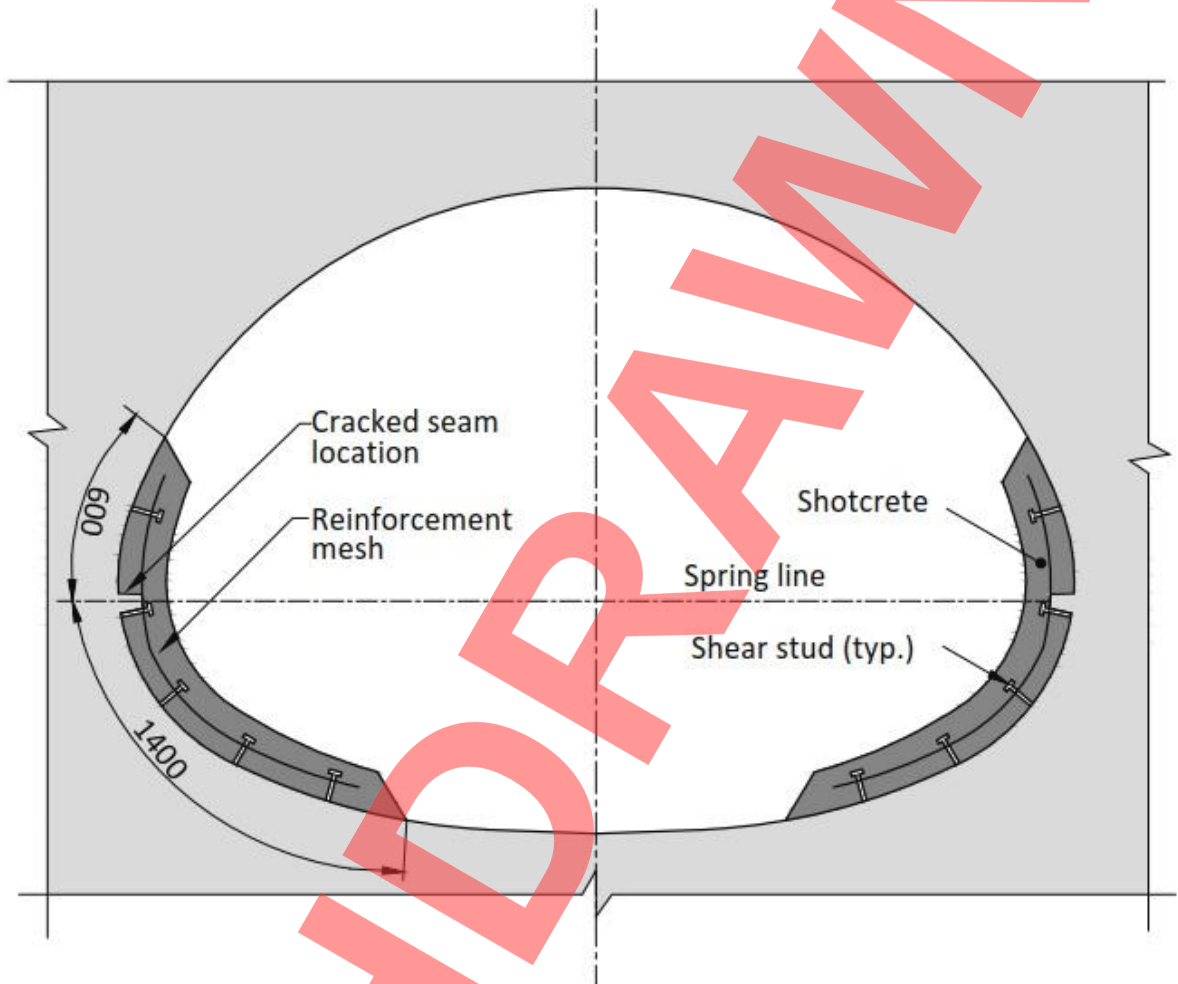
Figure B.12 Shotcrete reinforced concrete paving (after Abdel-Sayed et al, 1993)

A possible solution to increase the stability is the provision of a structural paving. Details of various arrangement for structural pavings are shown in Figures B11 to B14, and as indicated in Alexander et al 1994 [Ref 14.] and in 'Invert replacement of corrugated metal structural plate pipe' Ikerd 1984 [Ref 11.].
