Highway Structures & Bridges  
Inspection & Assessment

## CS 460

# Management of corrugated steel buried structures

This document details the management requirements for corrugated steel buried structures.

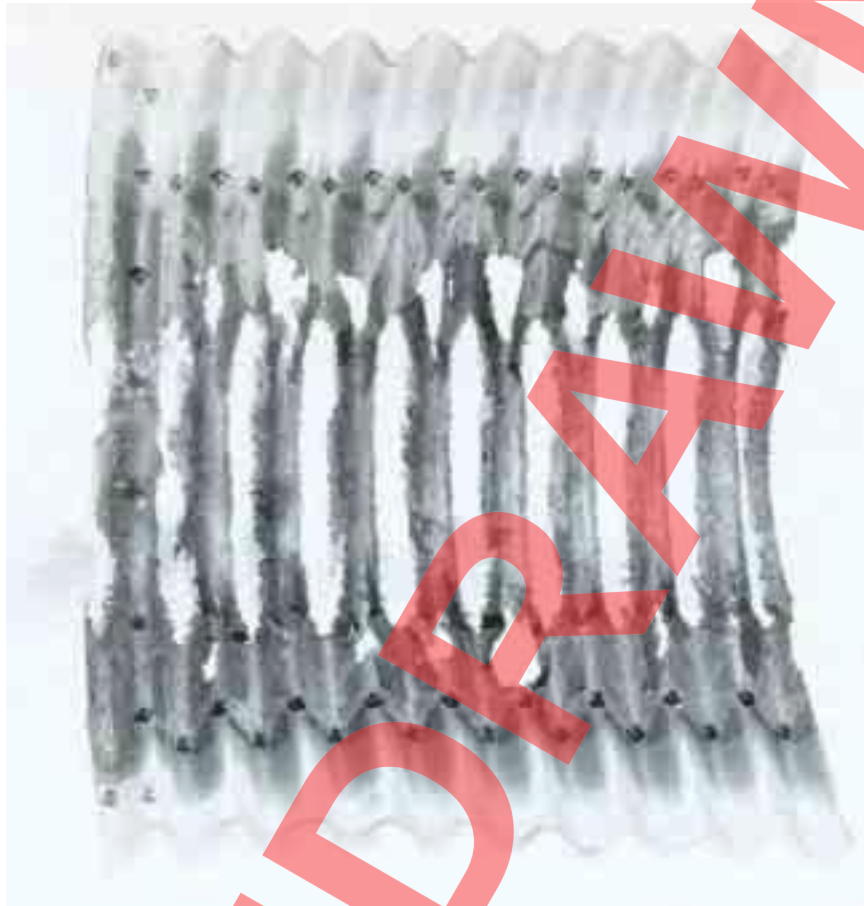
**Figure B.1 Example of extreme corrosion in the invert of a structure subject to scour (this 30 year old structure was not provided with a paving or bitumen coating)**

Figure B1 shows the deterioration in the invert of a 1.8 m diameter CSBS. This structure was subsequently replaced with a larger diameter helically wound corrugated steel pipe incorporating a reinforced concrete paving. If the deterioration had been less severe it might have been possible to install a reinforced concrete structural paving.

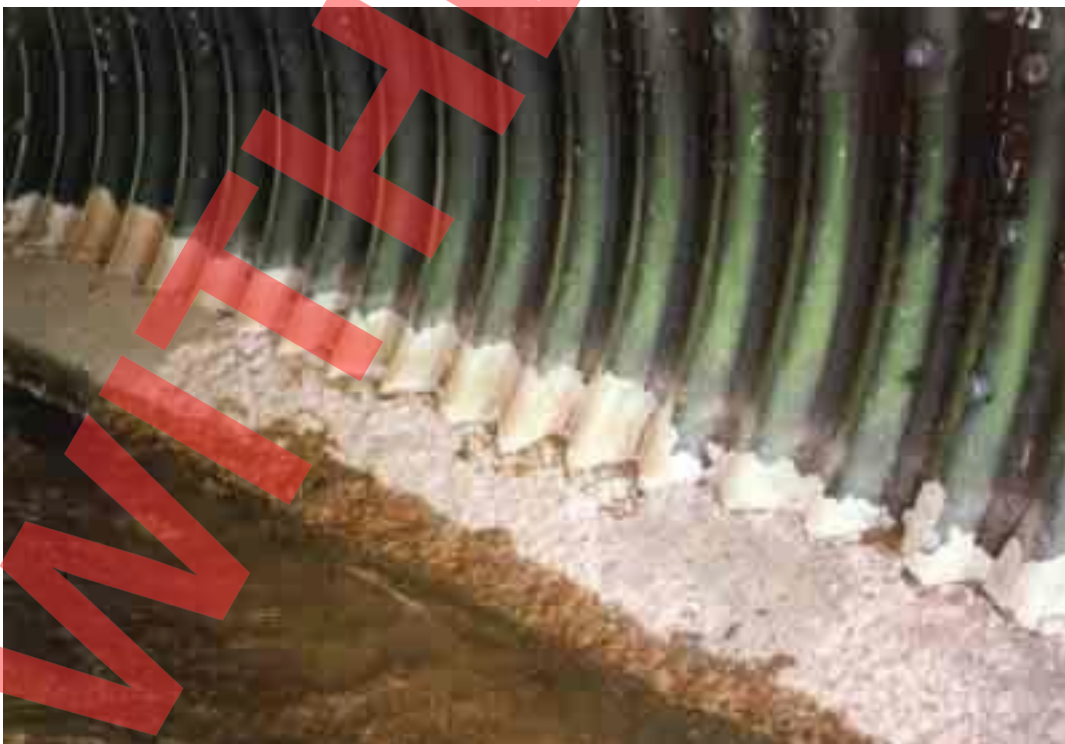
**Figure B.3 Damaged bitumen coating caused by overtopping of paving during turbulent flow**

Figure B2 shows typical deterioration of a bitumen coating caused by frequent cycles of wetting and drying. Figure B3 shows the deterioration of the bitumen coatings above the paving in a pipe arch structure due to overtopping through turbulent flow. In Figure B3 the bitumen coating was in good condition elsewhere in the structure.

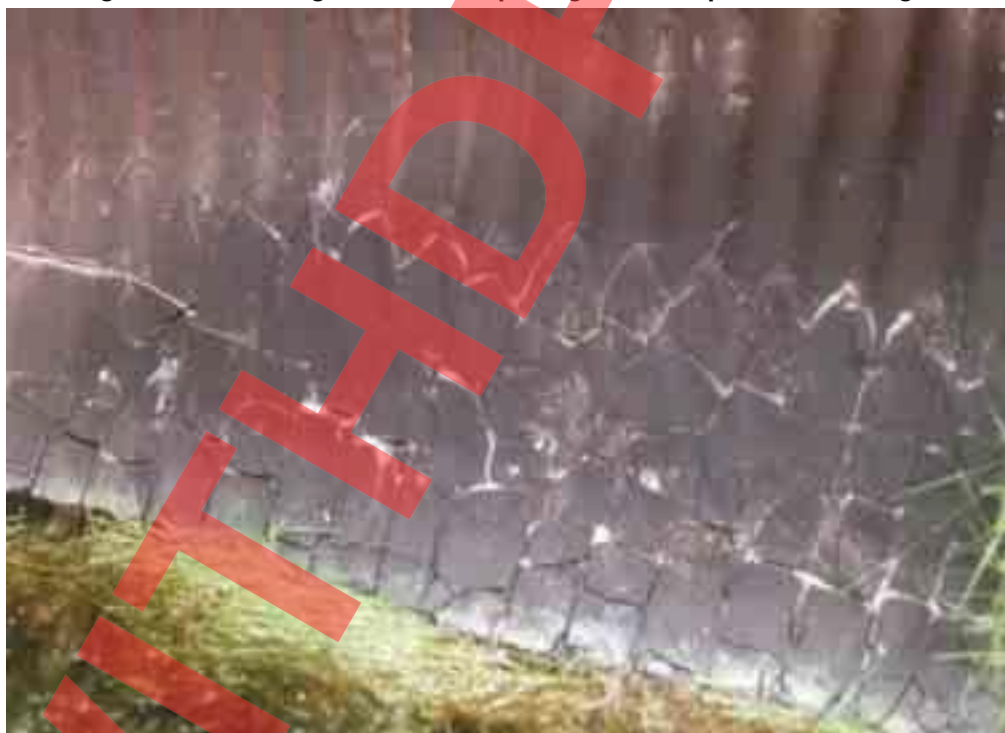
Figure B.5 Cracking in a bitumen paving due to exposure to sunlight

Bitumen pavings are generally hard wearing and resistant to scour by water-borne debris. The most common form of deterioration of bitumen pavings takes the form of cracking as the bitumen hardens with age and loses its more volatile constituents. This is usually most evident at the ends of the structure (particularly those with bevelled ends) exposed to direct sunlight and potentially turbulent water flows. Figure B5 shows an example of the form of deterioration.

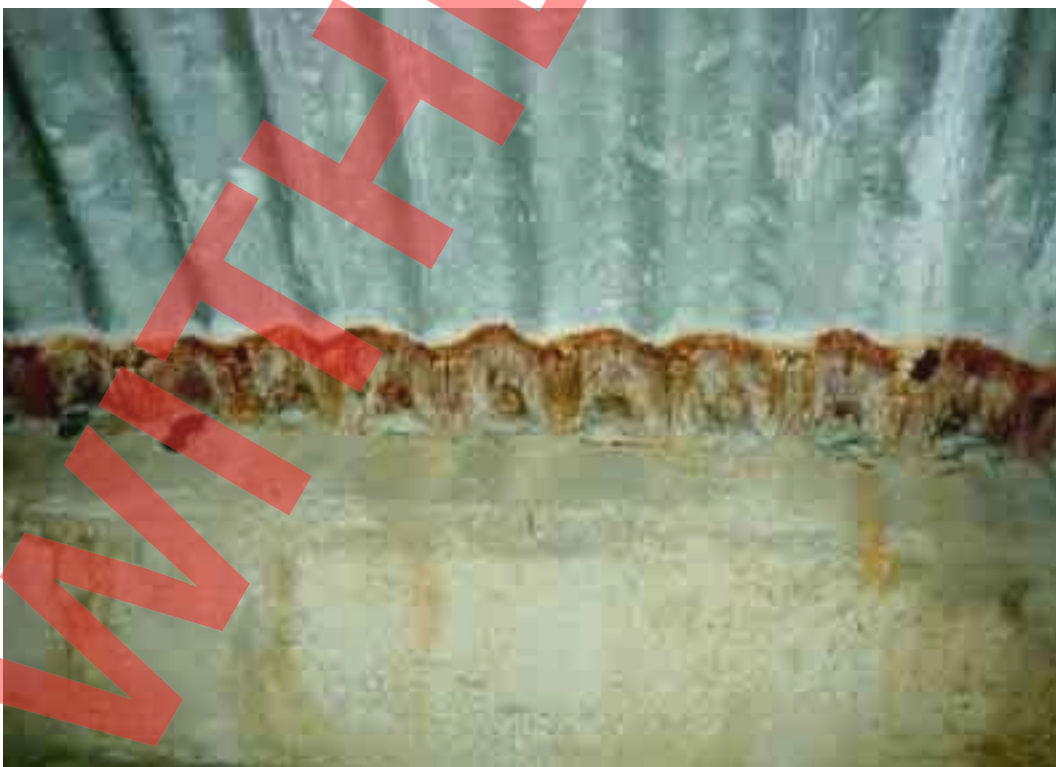
**Figure B.9 Deterioration at the arch seating of a plain galvanised arch structure due to seepage and ponding of water containing de-icing salts**

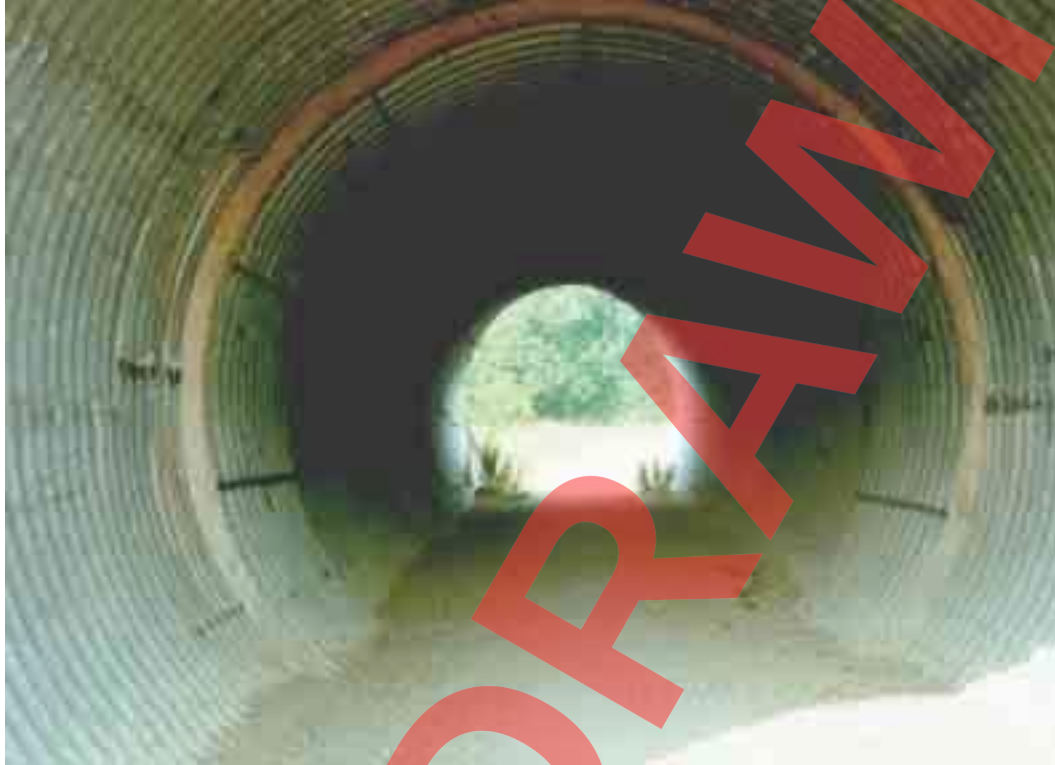
**Figure B.10 Use of liner plates to repair a bolted segmental CSBS showing deterioration below the edge of the carriageway due to seepage of water containing de-icing salts**
