**VOLUME 3 INSPECTION AND
SECTION 2 MAINTENANCE**

BD 54/15

**MANAGEMENT OF POST-TENSIONED
CONCRETE BRIDGES**

This standard provides the requirements and guidance for the management of post-tensioned concrete bridges. It implements a risk based approach to management and includes advice on Special Inspections, monitoring, repairs and strengthening.

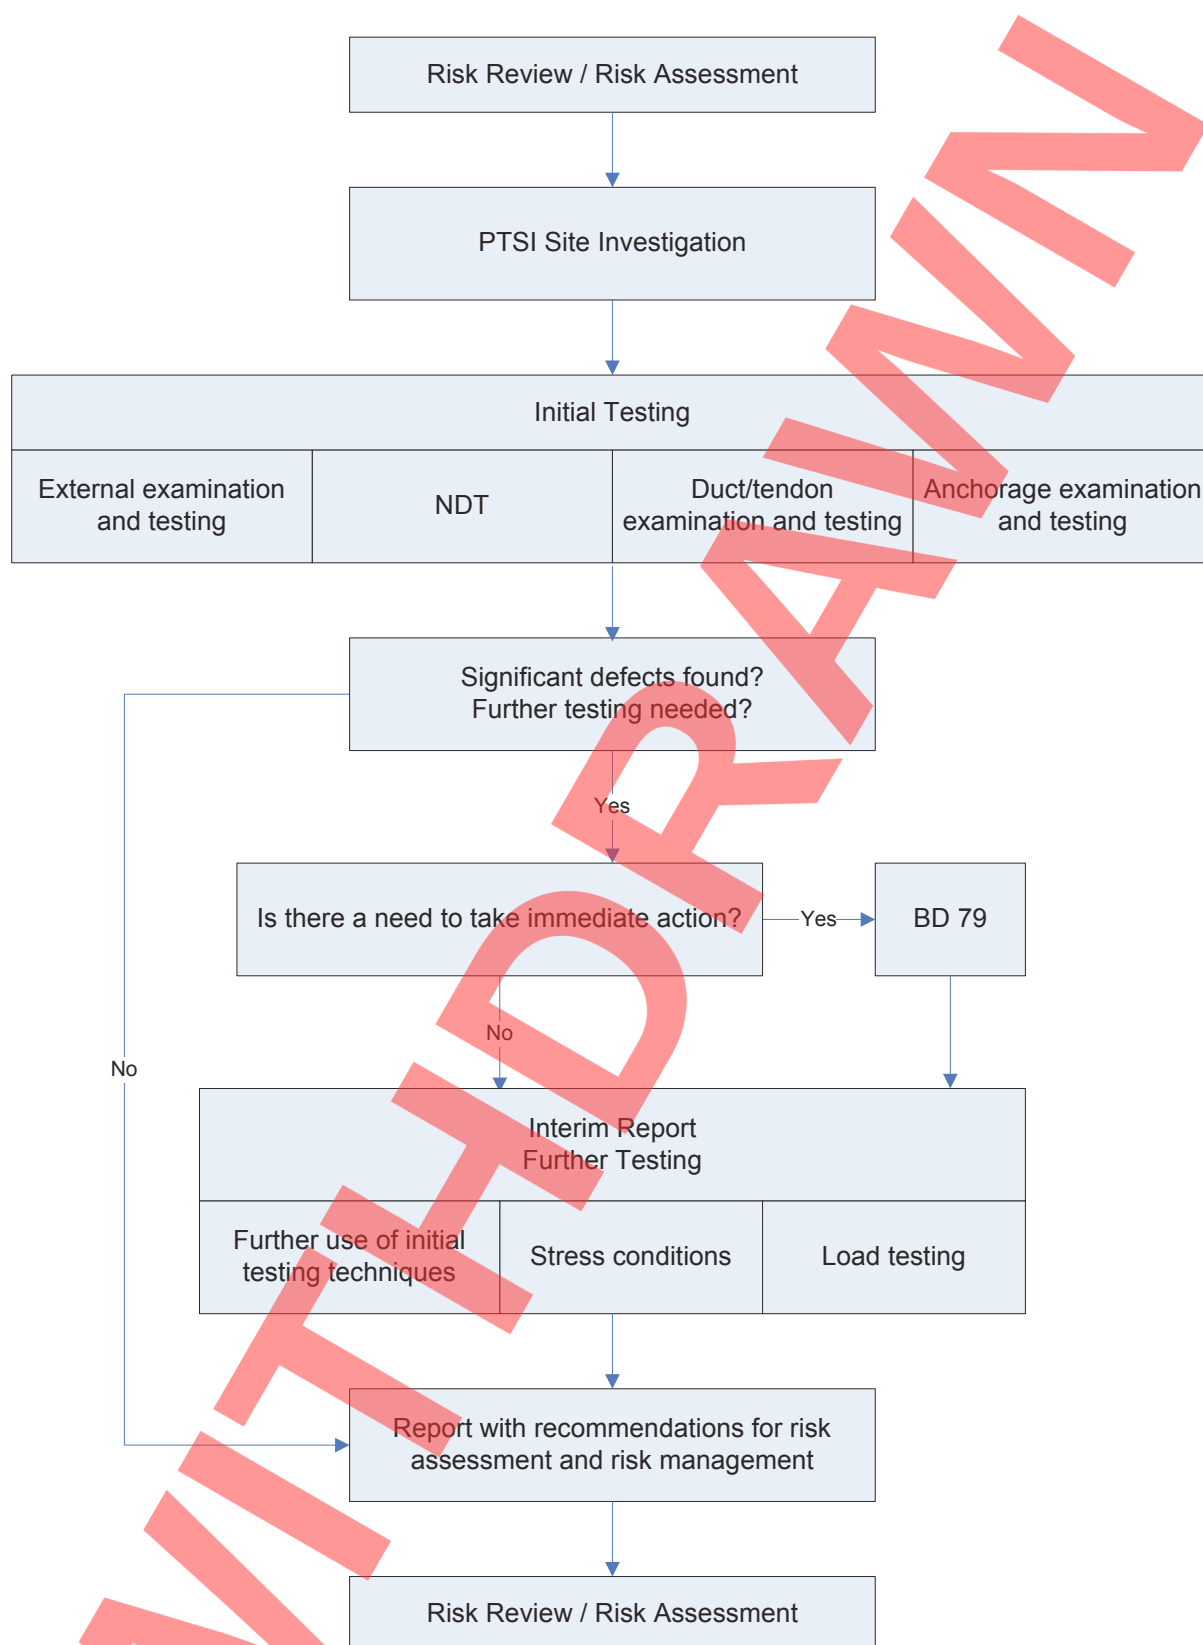
- 7.1 The general procedure for a Site Investigation is illustrated in Figure 7.1. In many cases, it may be sufficient to carry out only the initial testing tasks. Where problems are encountered and additional testing is considered necessary, then further investigation should be undertaken.

Figure 7.1 – Basic steps for a PTSI Site Investigation
